No. 341

CALIBRATION AND LAG OF A FRIEZ TYPE CUP ANEMOMETER

By Robert M. Pinkerton
Langley Memorial Aeronautical Laboratory

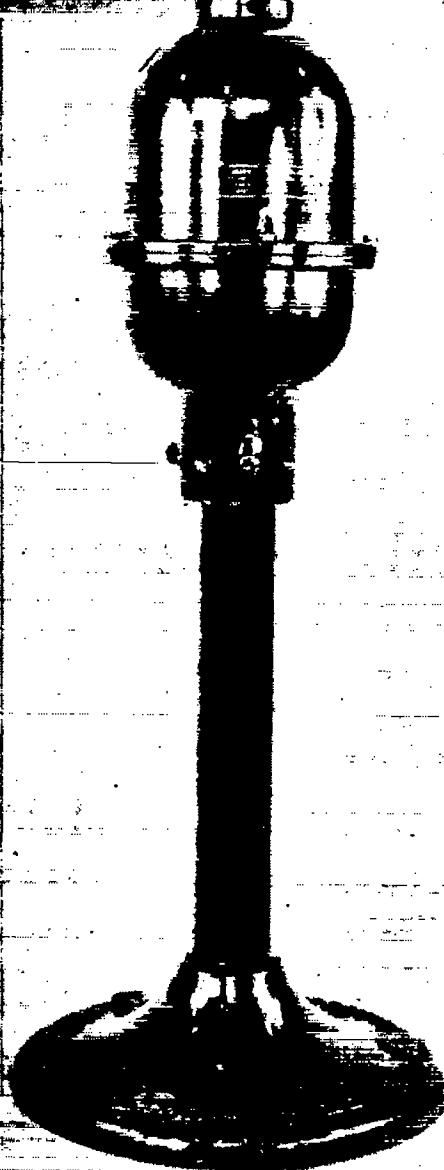
Fig. 1 Friez type cup anemometer.

The cup anemometer tested in this investigation is a three-cup type as shown in Figure 1. The cups, which rotate about a vertical axis, drive an electric generator housed in the body of the anemometer. The e.m.f. generated is indicated by a galvanometer provided with a scale to read in m.p.h. In these tests a photo-recording galvanometer also was used, and both instruments were connected to the generator leads through a double-throw switch so that either instrument could be quickly connected to the generator. The Pitot-static tube used to measure the true air speed was connected to a photo-recording pressure cell (Reference 1). The deflections of both instruments, together with timing marks at $\frac{1}{2}$ -second intervals, were recorded on a photographic film. The anemometer was mounted in the center of the air stream and rigidly guyed. The Pitot-static tube was mounted directly above the anemometer cups at a distance of 12 inches. The leads and tubes from these instruments were brought outside the tunnel through the regular equipment and connected to the recording and indicating instruments.

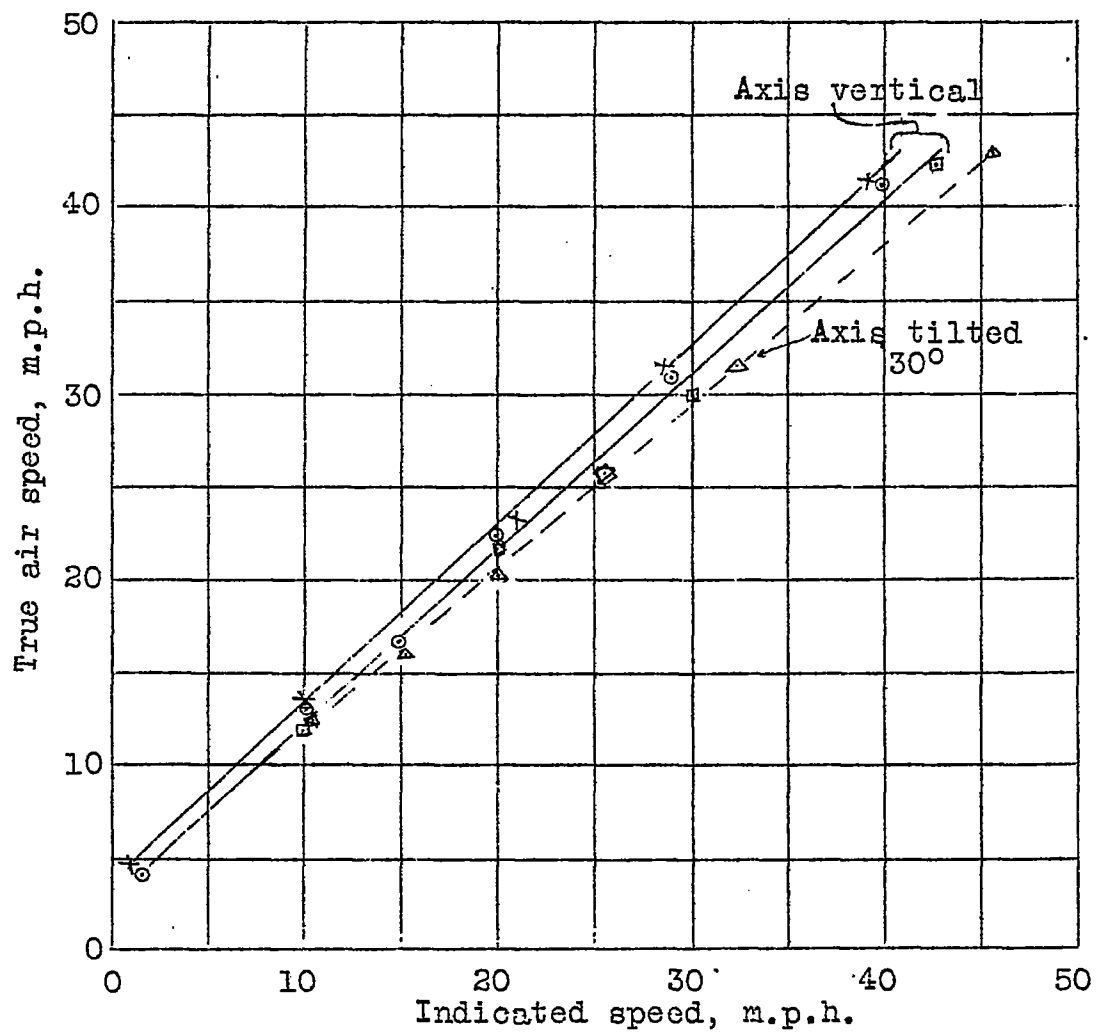
$\frac{4}{3}$ 1 Atmos. (photo-recorded)
 \circ 1 "
 \times $\frac{2}{3}$ "

Fig.2 Calibration curves of Friez type cup anemometer.

The results are presented as calibration curves (Fig. 2), lag curves (Figs. 5 to 10), and friction data (Table I). The calibration curves are obtained by plotting the true air speed, as measured by the Pitot-static tube, against the speed indicated by the anemometer. The lag was determined by comparing curves of air speed versus time in seconds from the Pitot-static

Because of the proximity of the Pitot-static tube to the rotating cups of the anemometer, it was thought that the interference of the anemometer upon the air flow about the Pitot might be appreciable. Hence, to determine the amount of this interference the velocity of the air stream was calculated from the static pressure obtained by means of a static-pressure orifice, located in the return passage of the tunnel and calibrated against a Pitot-static tube placed in the center of the air stream, the anemometer being removed. This velocity was compared with that calculated from the Pitot-static tube with the anemometer in place, and the results indicated that there was no appreciable interference between the anemometer and the Pitot-static tube. Figure 2 indicates two factors which affected the instrument calibration, namely, the attitude of the anemometer with respect to the air stream, and the density of the air. With the axis inclined forward 30 degrees the indicated velocity was approximately 6 per cent higher than it was with the axis vertical. At the reduced pressure, the indicated velocity was approximately 6 per cent lower than it was at atmospheric pressure, indicating that an altitude factor should be applied to the latter calibration. Another factor which may have affected the calibration is that the instrument was
